Nisqually Meadows HOA

Subject: Nisqually Meadows Geotechnical Consultation Report
TPN: 65080300000; 105th Ave SE, Yelm, WA
QG Project No.: QG23-134

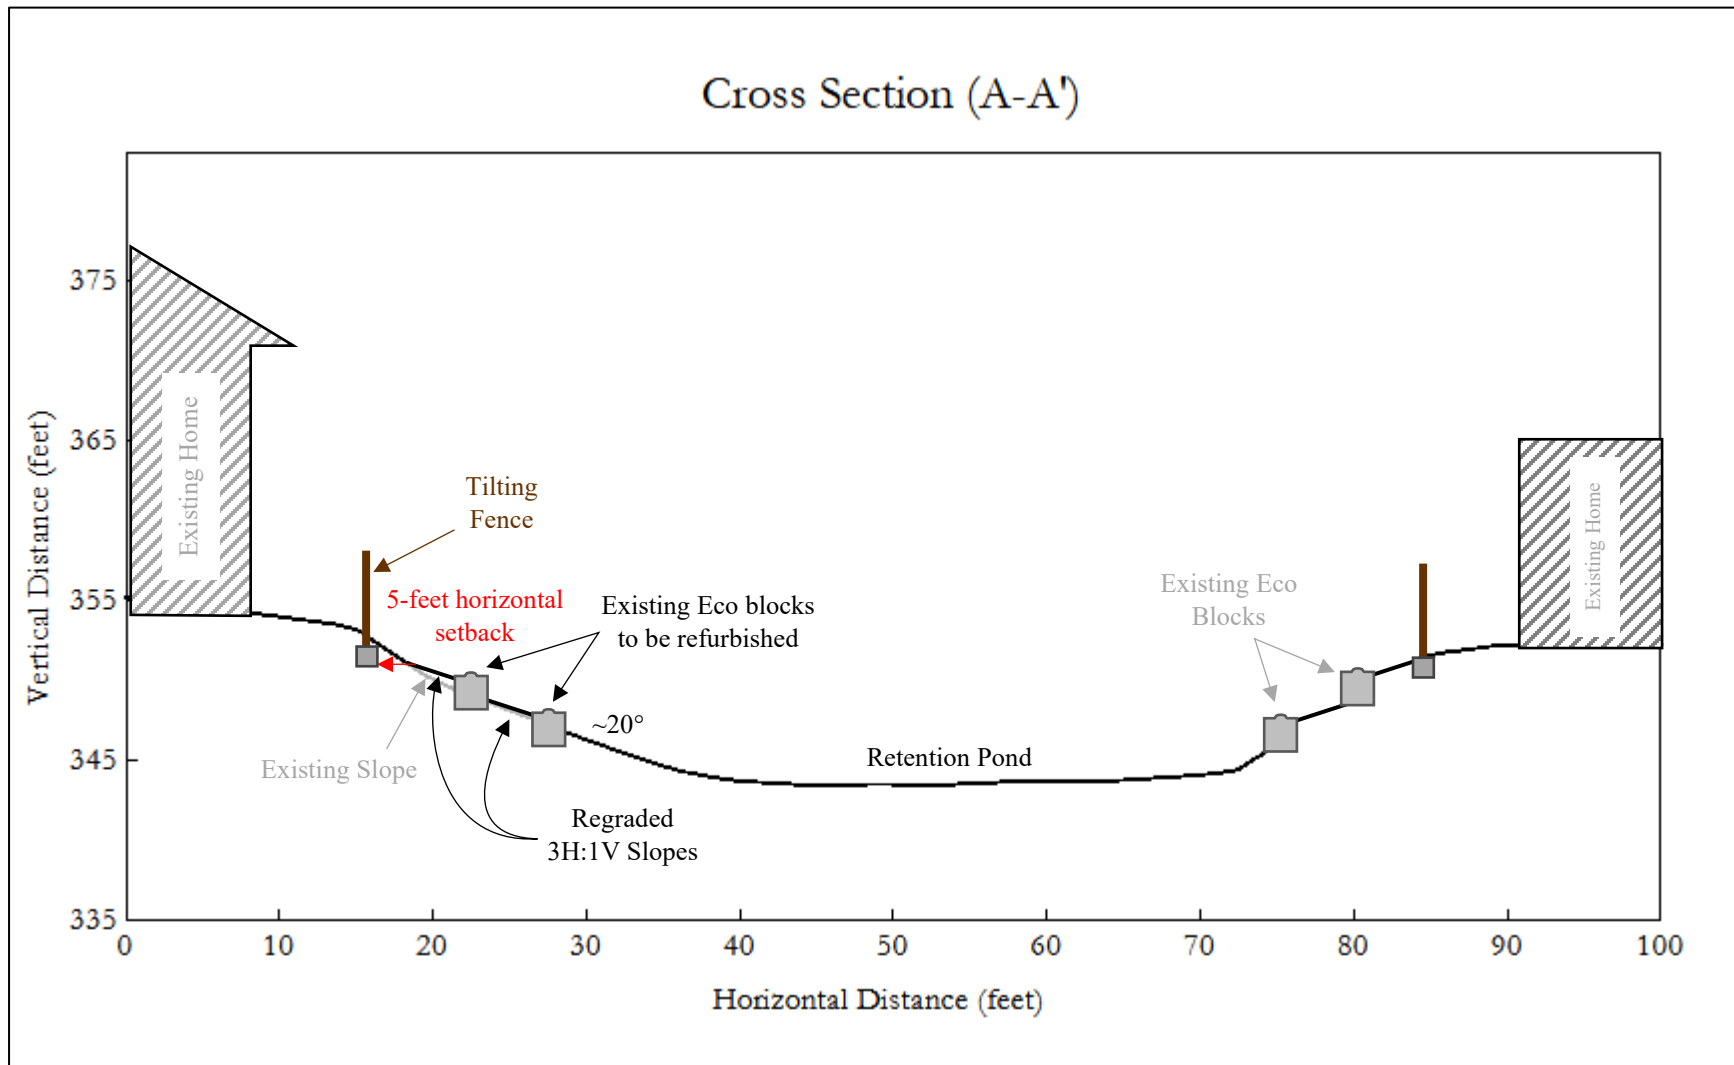
Figure 3

Slope Profile A – A'
Nisqually Meadows Geo

QG anticipates that the fence will need to be replaced or restored. QG recommends that the concrete for fence posts be embedded and buried a minimum of 18 inches to protect from frost heave. Additionally, the concrete for the fence post should be imbedded enough so that there is a horizontal distance of 5-feet from the base of the concrete to the slope face. See Appendix C, figure 3.
